# MORROW MOUNTAIN STATE PARK PLAN

The State of North Carolina  
Department of Natural Resources and  
Community Development  
Division of Parks and Recreation  
Master Planning Unit  
P.O. Box 27687  
Raleigh, NC 27611  
Telephone: (919) 733-5245

February, 1979

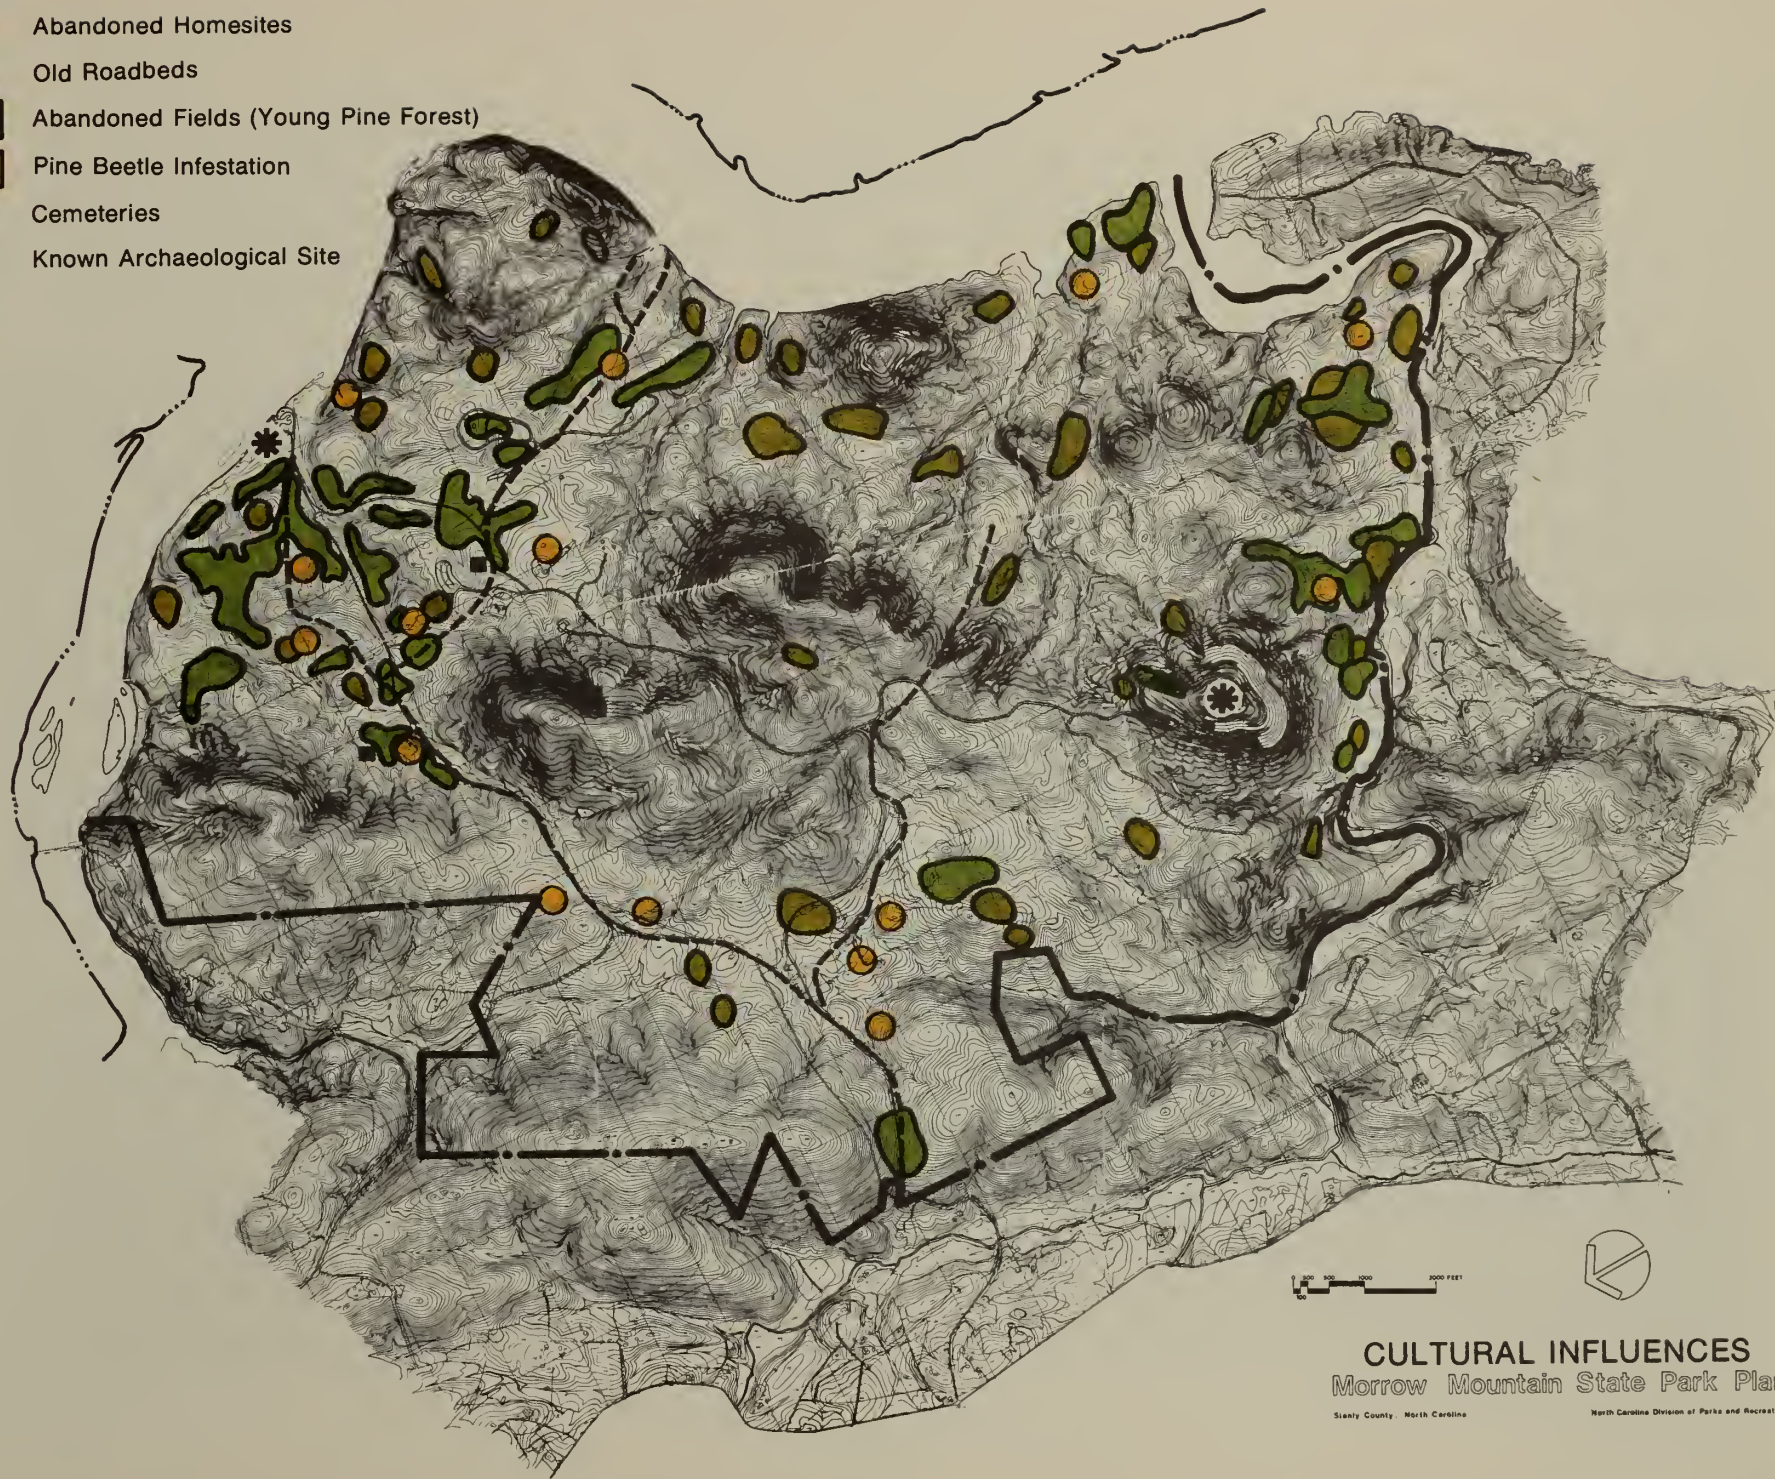
**CULTURAL INFLUENCES**  
Morrow Mountain State Park Plan

The impact of man's activities on the park landscape over the last century remains visible. Despite a forty-year old policy of natural resource preservation, the location of old dwellings and roads and the boundaries of abandoned fields are still discernible. Although this condition is not unique to Morrow Mountain State Park, it is among the most interesting characteristics of the park area. As one would expect, these elements are found together, clustered in particular areas of the park.

The greatest number of abandoned homesites, cemeteries, roads, and fields is in the northeast portion of the park. The key factor contributing to this condition is the old Lowder's Ferry Road also known as the Salisbury-Fayetteville Road, which provided access to the Pee Dee River at Lowder's Ferry. At least ten homesites have been identified within this area. Also related to this roadway are the sites of the old Stony Hill Church and Lowder's Inn, near the Ferry. The floodplain and adjacent slopes

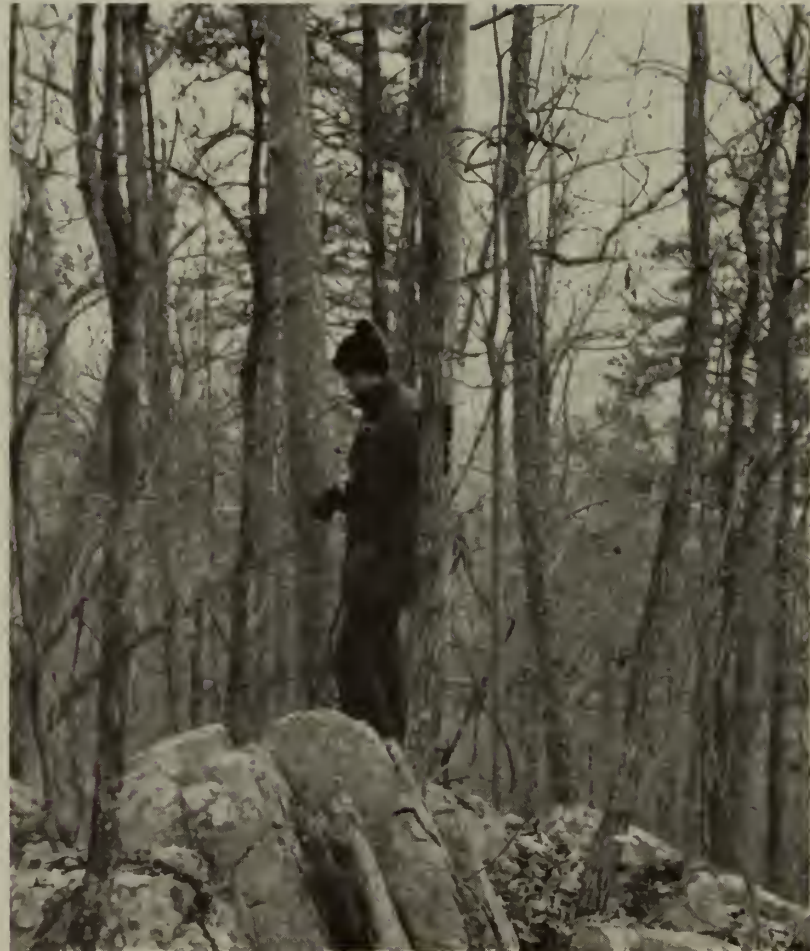
In areas of high ground, oak and hickory species are the canopy trees found mixed with pine. On the lower slopes associated with the drainageways, mesic species such as red maple and tulip poplar are found in greater abundance than oak and hickory. Soils throughout the mixed forest consist primarily of the Georgeville series, which are characterized by silty-textured surface soil and silty clay subsoil. Generally, the soil is well drained, and, in upper elevations, excessively drained.

Slopes in this cross-section may range from 2 percent to 8 percent on the ridgetops and up to 12 percent on side slopes associated with drainageways. An important pattern repeated throughout the area is the prevalence of abandoned homesites and associated roadbeds. The sites are mostly found along

ridgetops or on knolls. These features may have historical or interpretive interest but, more important, proven building sites with optimum site conditions: well drained soils, good foundation material, and mature canopy trees. Sixteen old homesites were identified from aerial photographs, and a field survey would indicate a number of additional sites.

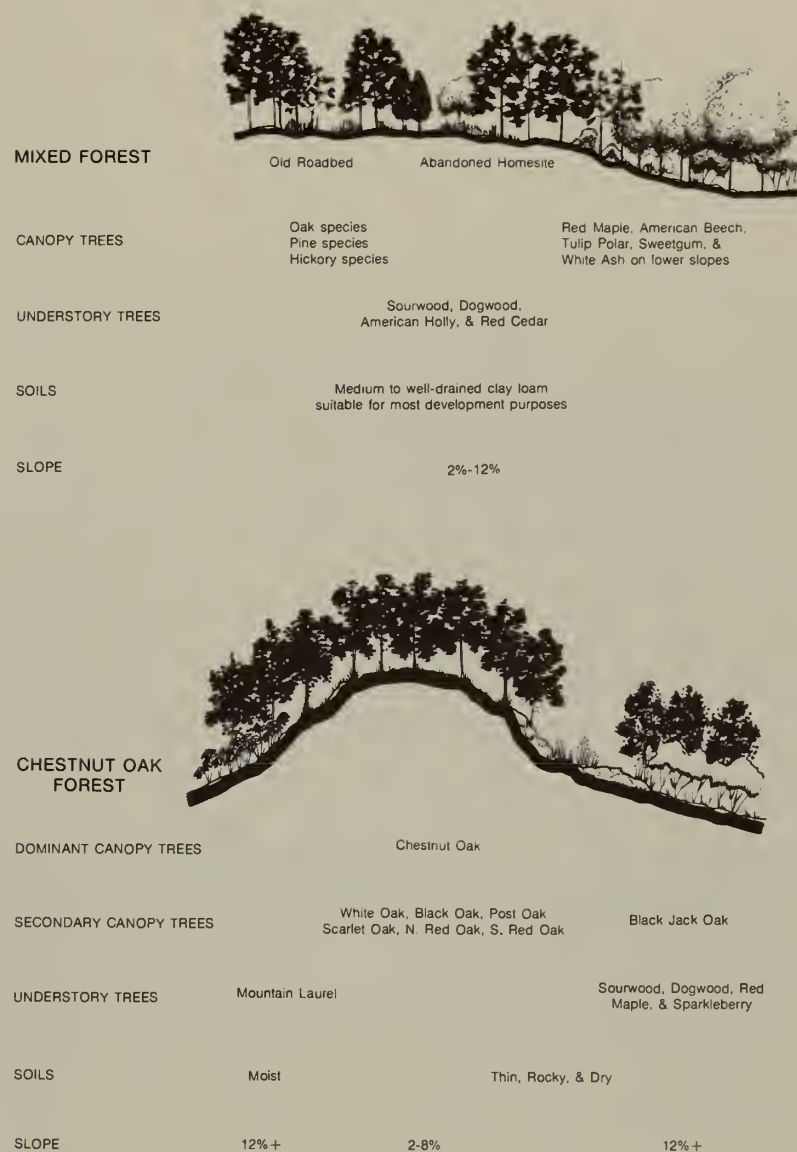
The Chestnut Oak Forest, which dominates the upper elevations in the area, is the most unique major habitat in the park. Because the soils are quite shallow in the mountainous areas, coupled with drying winds, quick drainage, and periodic droughts, chestnut oak (*Quercus prinus*) thrives. In sample areas through the park this species was found to compose approximately 70 percent of the canopy within the chestnut oak community. The remainder of the canopy vegetation is composed almost exclusively of other oak species.

This forest community covers the steep rocky slopes along the higher ridges and monadnocks in the park. On the dry south-facing slopes blackjack oak appears in greater abundance with understory trees including sourwood, dogwood, and sparkleberry. The moist north-facing slopes are the habitat of mountain laurel, which grows in thickets in the lower elevations of this community.

Because of prevailing slope and soil conditions, the chestnut oak forest is the most limited natural community in its desirability for use and ability to sustain development. Trail development is possible provided gradients permit or if trails are confined to the ridgetops.

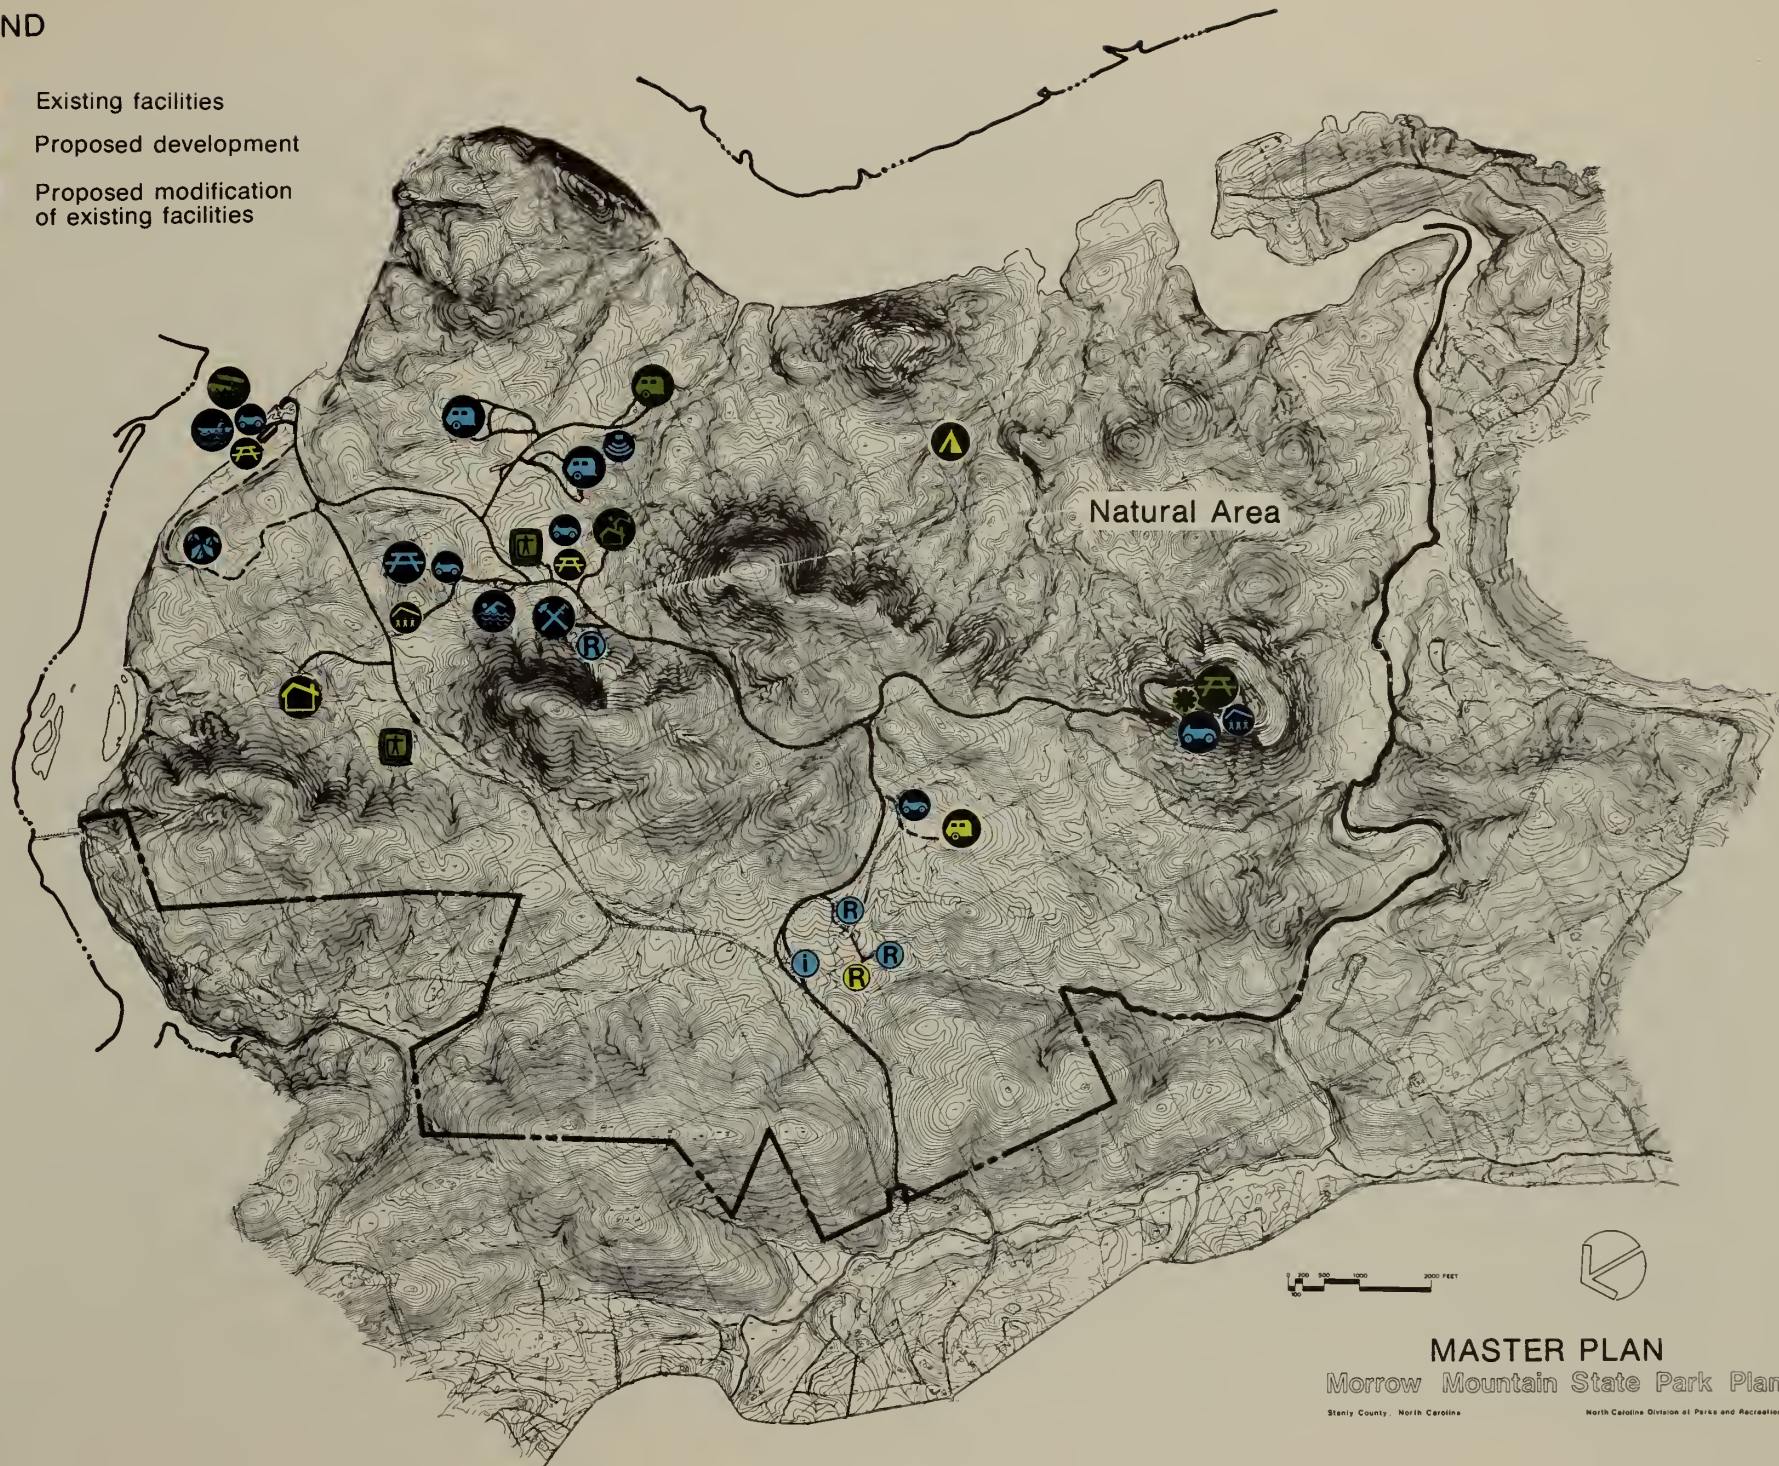
- Existing facilities
- Proposed development
- Proposed modification of existing facilities

The overall trail system for both hiking and horseback riding is in good condition. Relatively little trail needs reconditioning or realignment. The trails, however, are not as continuous or extensive as they could be. Trail links are especially needed to tie Morrow Mountain to other parts of the park.

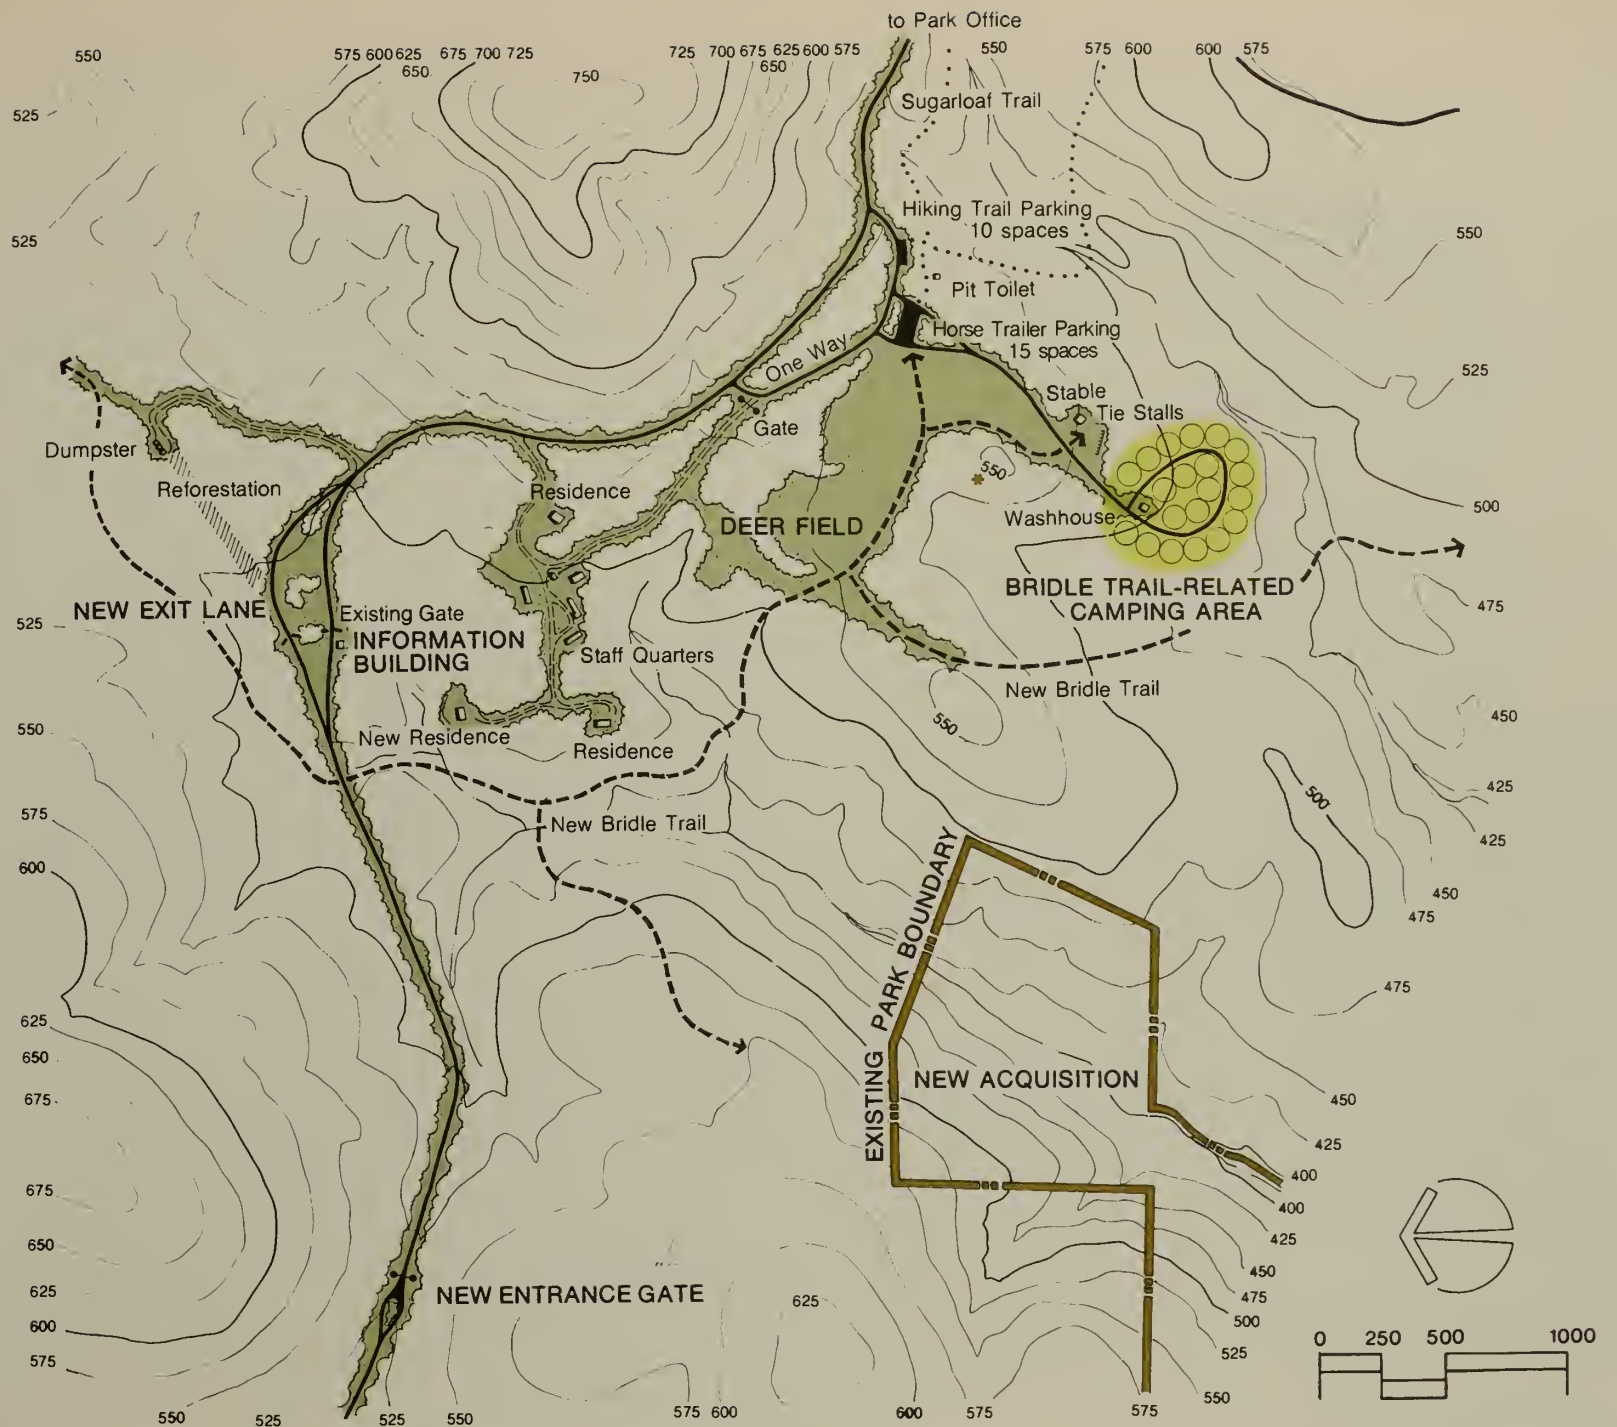
SITE PLAN FOR PARK ENTRANCE

As a last measure for improving the entrance area, the actual control gate will be moved from its present location at the stone wall approximately 2,000 feet further west to where the road crosses a saddle between two large hills. Relocation of the control gate will eliminate its undesirable proximity to the staff residences.

In summary, the proposals affecting the park entrance area are:

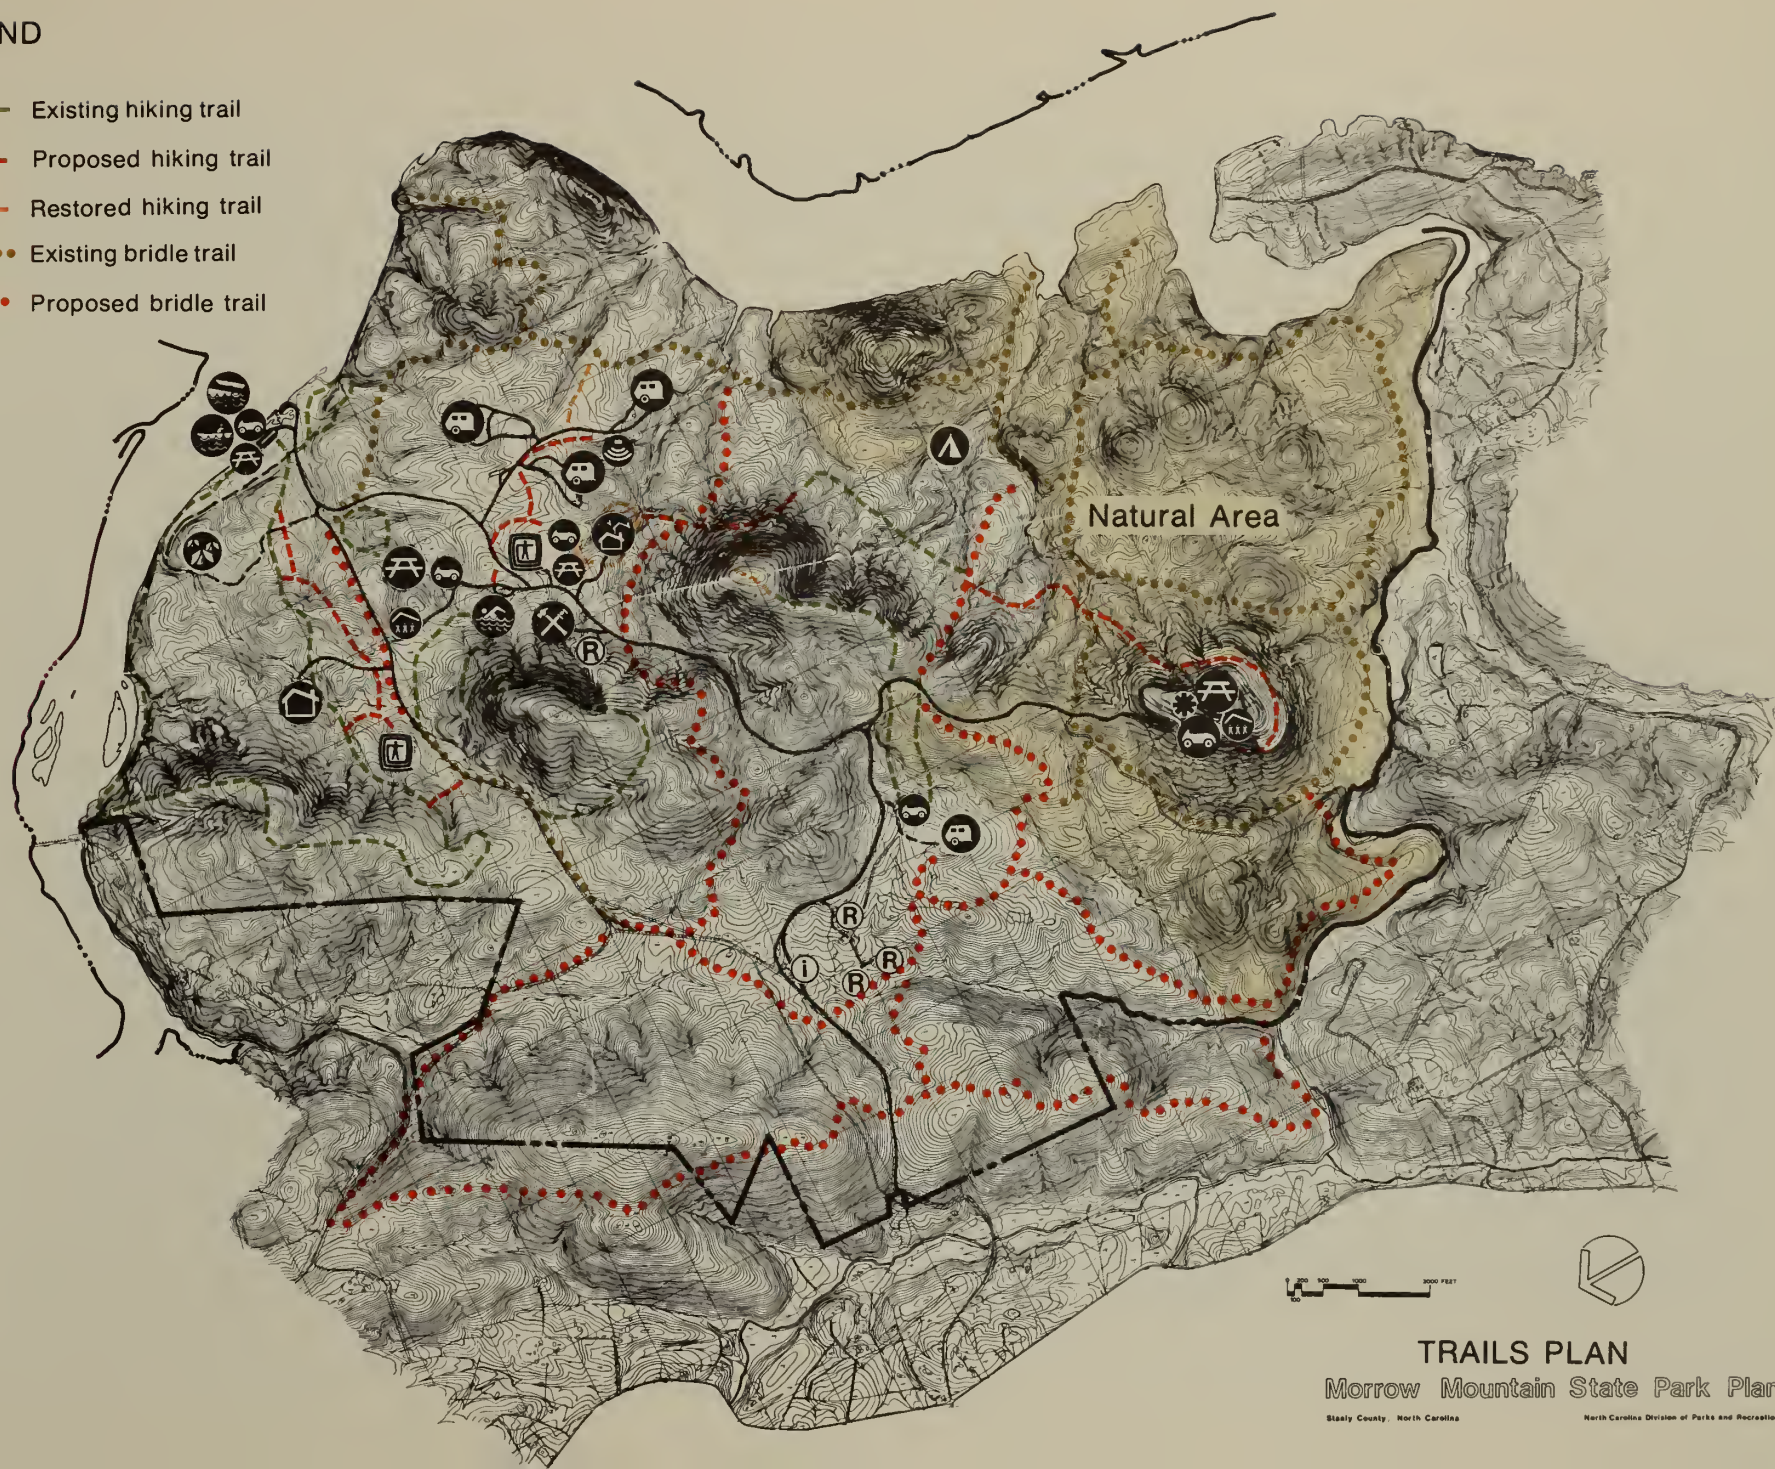
TRAILS PLAN  
Morrow Mountain State Park Plan  
Stallins County, North Carolina North Carolina Division of Parks and Recreation

Several of the hiking trails need maintenance and proper surface treatment because of soil compaction or erosion. The Laurel Trail and the Quarry Trail are especially in need of renovation. The entire southern section of the Sugarloaf Mountain trail, where it descends the mountain, needs to be reworked. The mountain is very steep and, in many places, the trail has been completely eroded. Although the general location of the trail is satisfactory, its surface needs renovation and a new set of switchbacks. About 800 feet of the Hattaway trail must be eliminated and relocated on more compatible slopes, adding slightly less than 1/2-mile to the existing trail. The very northern portion of the Fall Mountain Trail, where it descends the mountain to the river, must also be reworked. Here again, the trail is much too steep for hiking and must be realigned to maintain reasonable gradients.

The majority of existing trails are for both hiking and horseback use, but are officially designated as bridle trails. Frequently they follow abandoned roadbeds and serve as firebreaks. These trails, which total more than ten miles, are generally in good condition with little need for extensive renovation. However, a 1/2-mile section which circumvents the Kron House parking area and parallels the Kron road to its junction with the main park road

does need repair. The trail descends some steep slopes which are hazardous to both riders and horses in wet weather and can be relocated nearer to the Kron road to avoid the bad sections.

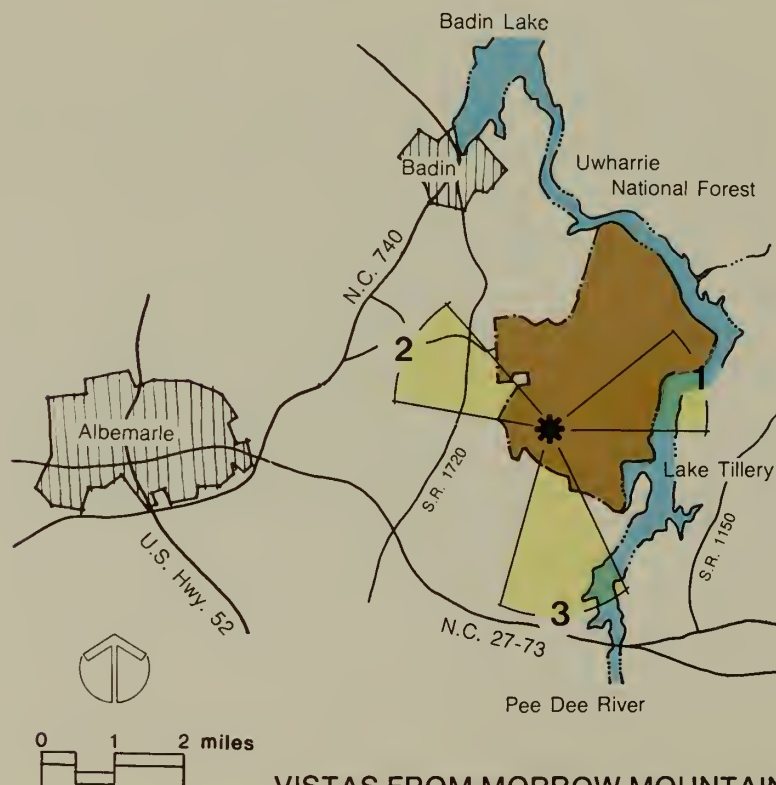
VISTAS FROM MORROW MOUNTAIN

Extensive improvements will be made at the scenic area on the top of Morrow Mountain, including improvements of the overlooks from the parking lot, rehabilitation of the ground surface, designation of picnic facilities, and provision of a self-guided trail. Most important, however, the pedestrian circulation pattern on the mountaintop will be redesigned for proper flow and containment. The lack of designated walking surfaces and inability to protect wooded areas are the principal problems at this site.

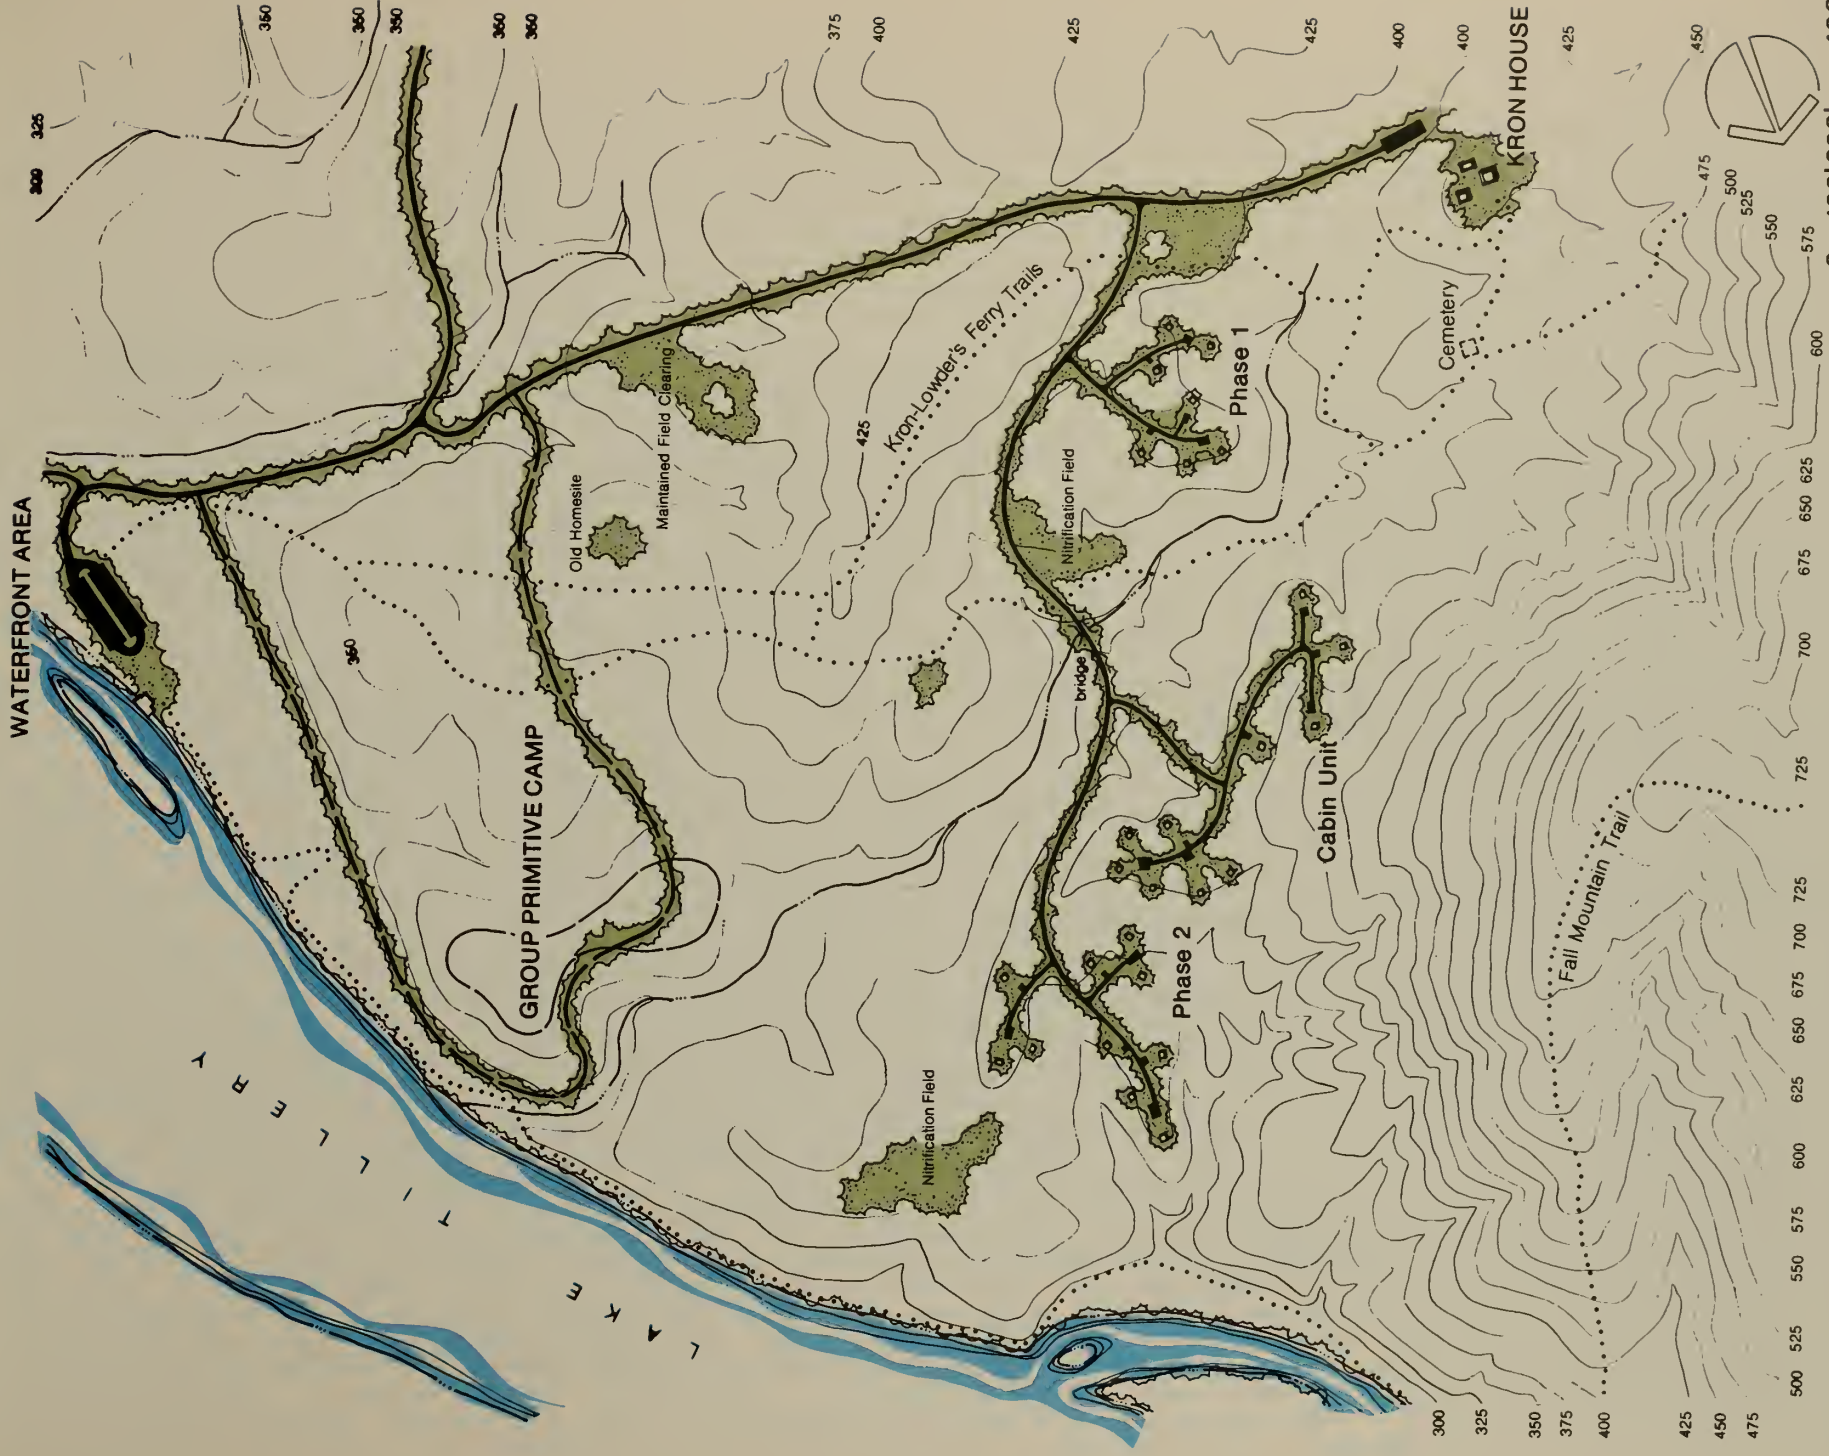
SITE PLAN FOR PROPOSED FAMILY CABIN COLONY

When the first stage of family cabins is completed near Fall Mountain, the existing cabins will be converted to group use. Because of the proximity to the interpretive center the cabin facilities will be rented exclusively to groups having environmental education themes. The cabin colony will remain available on a rental basis, therefore, to environmental education groups instead of the general public.

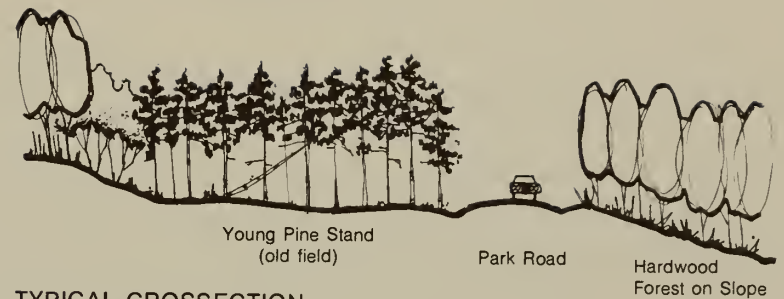
TYPICAL CROSSECTION

Along the road leading to the Kron House old fields adjoin the roadway in several places. These areas are best suited for the clearing proposal since the roadway is the least travelled in the park and would prove effective for observing wildlife from a car. Care will be taken to avoid soil erosion by clearing during a dry period and by preparing and planting native field covers common to old field succession as quickly as possible. Clearings are designed to be visible from the roadway and to provide depth and diversity within the open space itself. Eastern red cedar will be allowed to remain in these open areas, and perhaps cedar or hawthorne hedgerows could develop. Groves of fruit trees could also be an asset to the area.
